SAINT JOHN RIVER BASIN
Limestone, Maine

WEBSTER BROOK DAM ME 00229

PHASE I INSPECTION REPORT NATIONAL DAM INSPECTION PROGRAM

SEPTEMBER 1981

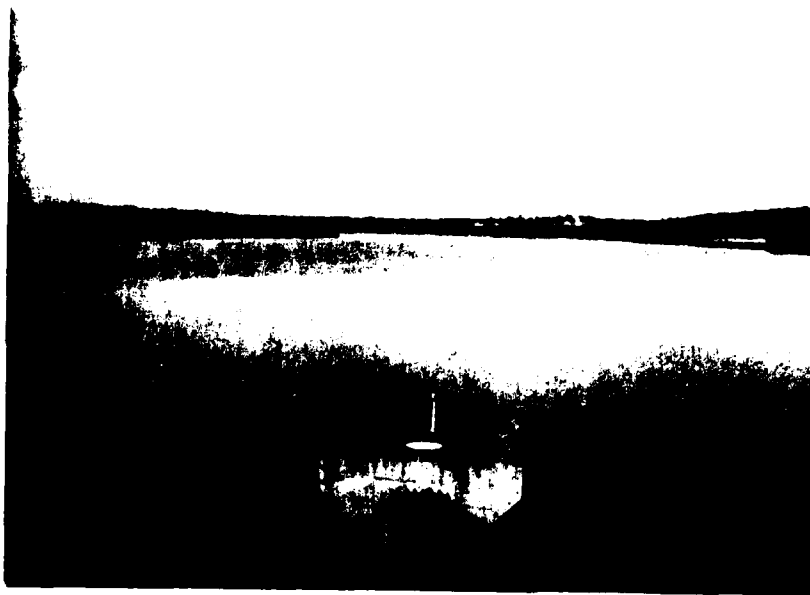
Photo #2
View of Principal
Spillway Intake
from Crest of
Dam.

(1) Principal Spillway - The principal spillway intake (Photo 2 and 3) was observed from shore. The exposed concrete and steel trashrack appeared in good condition.

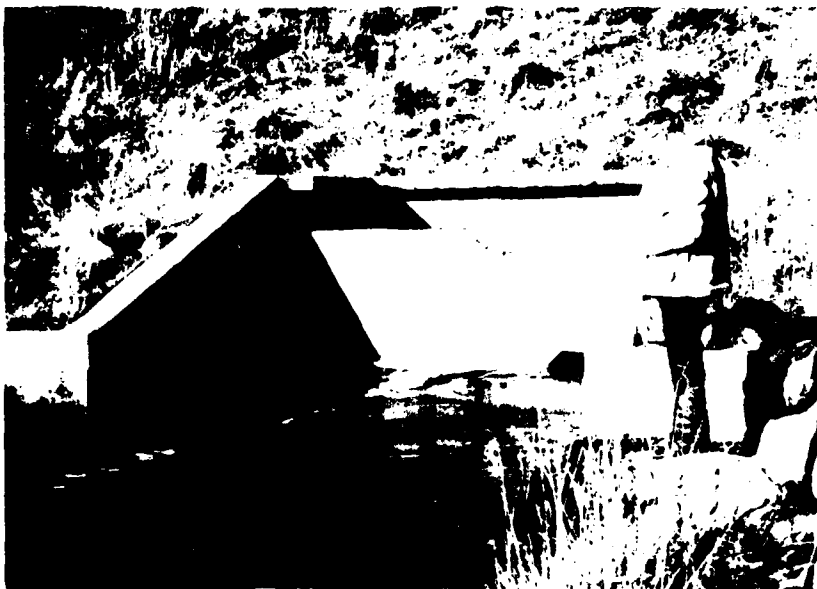
Photo #5

(2) Outlet works - The outlet impact basin (Photo 5) was found in good condition. All construction joints were tight. No spalling was observed. The reservoir drain inlet was submerged and could not be inspected. The outlet conduit could not be inspected. The control mechanism for the drain was reported to have been recently operated without problems by the Limestone Town Manager.

Concrete Outlet
Structure

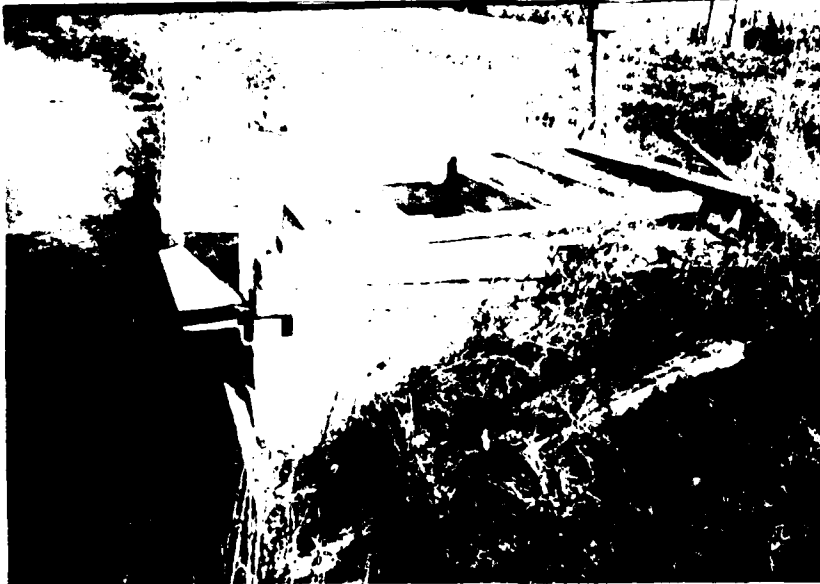
Photo # 8

Upstream Reservoir
